**US Army Corps
of Engineers®**

Demonstration Erosion Control Project Monitoring Program

Fiscal Year 1995 Report

March 2000

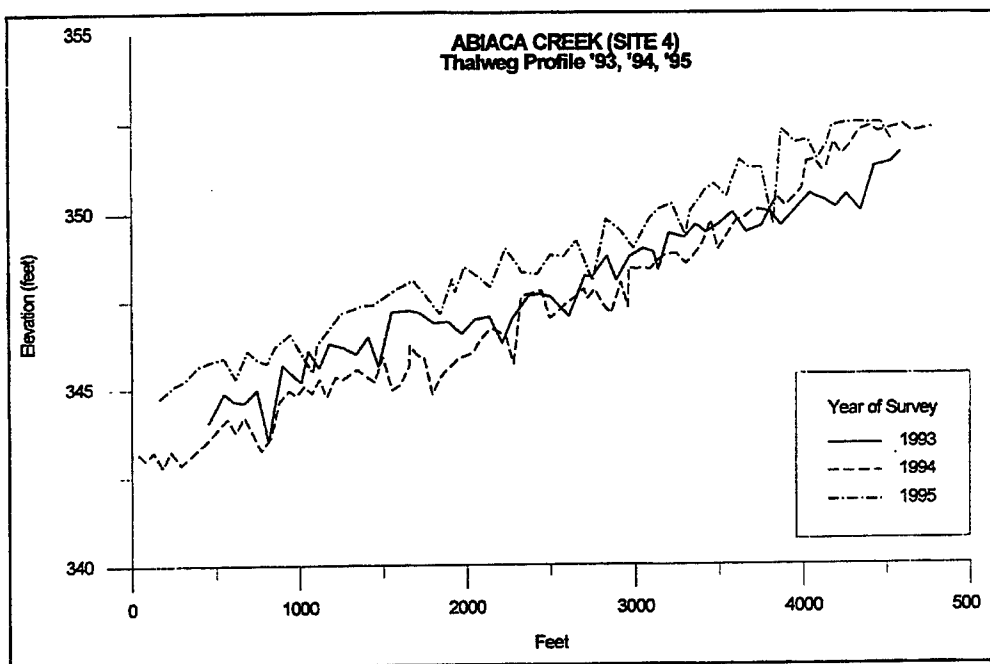
Figure 11. Thalweg profiles for Abiaca Creek, site #4

Site No. 4 is on Abiaca Creek and extends approximately 4,000 feet upstream from the confluence of Coila Creek as shown on Figure 10. This site is located in T17N, R2E, Section 4 and has a watershed area of approximately 44 square miles. This site is located approximately 1.8 miles downstream of a major sand and gravel processing operation that can be associated with increased supply of suspended and bed material load. Stream banks in this reach are relatively stable except as the channel impinges on high bluffs. The bed has fluctuated with a general aggradation for the past four years, and is a mixed sand/gravel reach. With the low summer and fall discharges, vegetation had encroached into the channel. No vegetation was observed to be permanently affecting the channel, and will be removed unless the low flow persists. See Table 3 for summary results and Figure 11 for thalweg profiles.

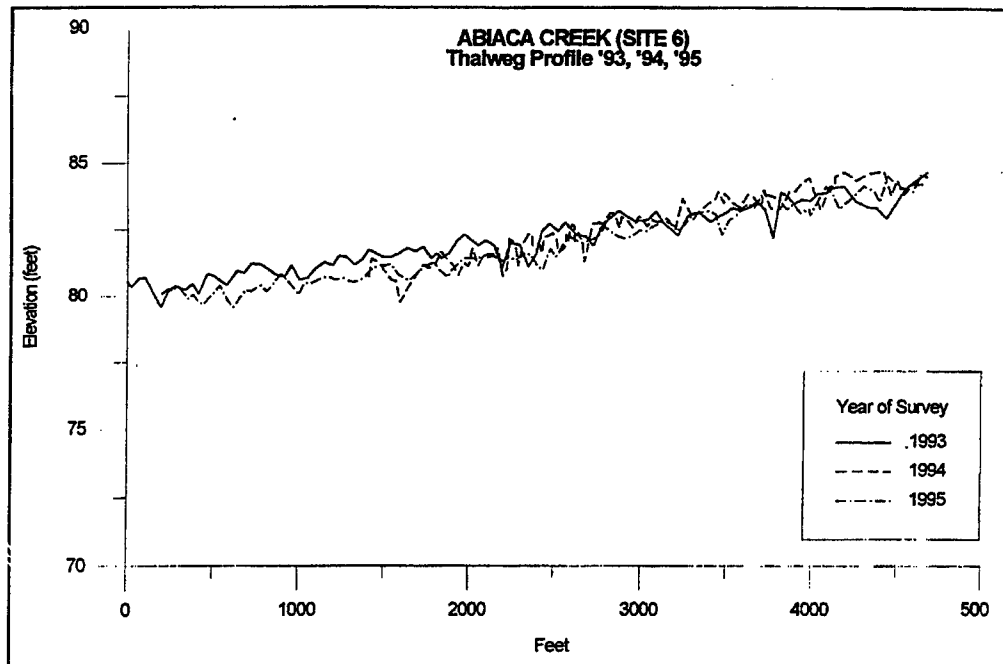
Figure 13. Thalweg profiles for Abiaca Creek, site #6

The thalweg profile and channel dimensions have been relatively constant since 1992. A project to construct a sediment trap at this site was observed to be under construction in 1995. Later monitoring results will be impacted by that construction. See Table 4 for summary results and Figure 13 for the thalweg profiles.

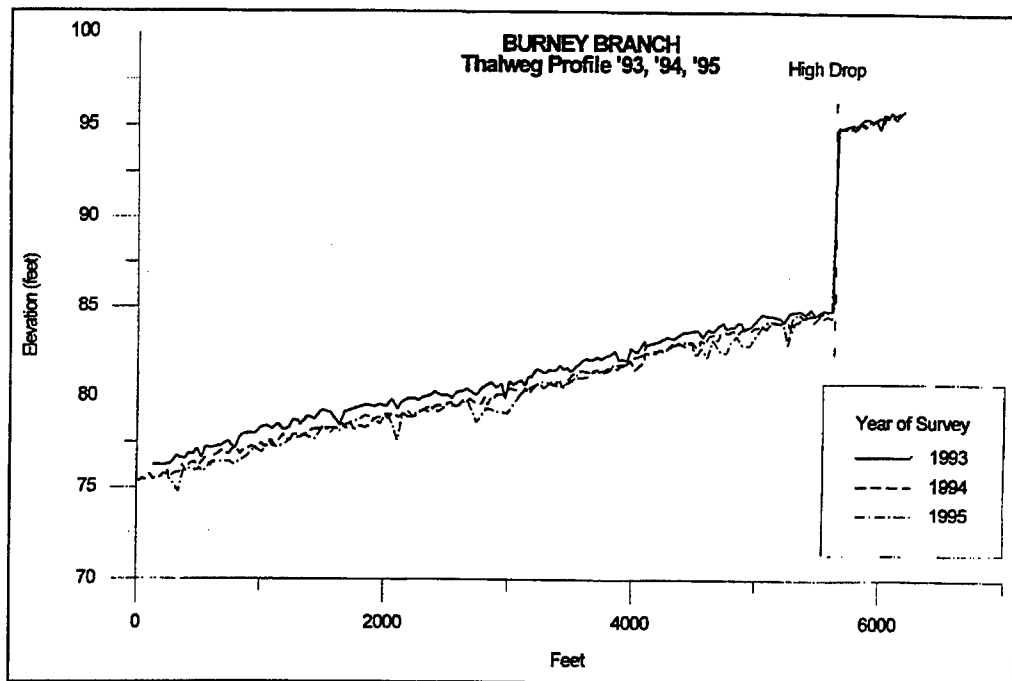
Figure 17. Thalweg profiles for Burney Branch, site #12

The two high-drop structures have been very successfully utilized in rehabilitating this reach of Burney Branch. Both structures were constructed in 1982 by the SCS, and the effects of the structures on the channel were surveyed and analyzed by Watson et al. (1984). These structures were designed to contain the 100-year discharge and include the provision for floodplain storage using valley dams in conjunction with each structure. The original design of the structures provided for a bed slope of 0.0008 between structures, based on Lane's tractive stress analysis. The 1984 surveyed bed slope was 0.0012, indicating that the upstream sediment yield was greater than planned. Since 1984, several major channel stabilization projects have been constructed upstream. Channel stabilization under conditions of decreasing sediment supply is a situation that will be faced as the success of the DEC programs are realized. Potentially, upstream stabilization can cause stability problems downstream.

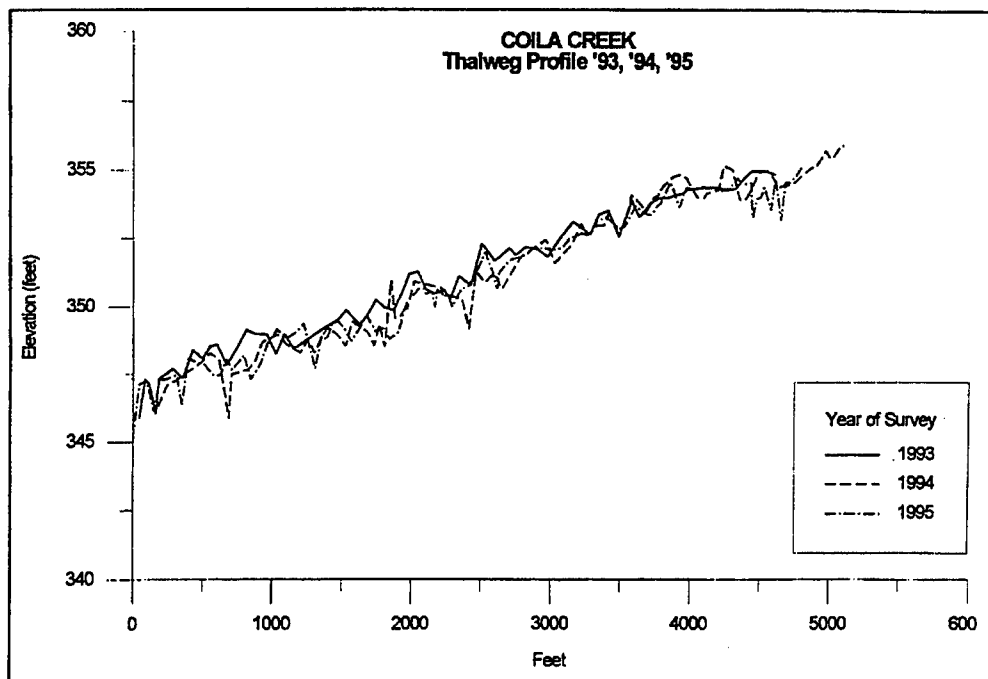
Figure 19. Thalweg profiles for Coila Creek, site #5

The reach thalweg profile has no significant trends, and the bank stability was poor only near the confluence with Abiaca Creek in a bendway. The D_{50} of the reach was sampled and analyzed to be 10 mm, which does not allow reliable SAM computations using the sand-bed based equations. The upper portion of the reach is has a very stable inner-channel with a gravel bed and overhanging riparian vegetation.

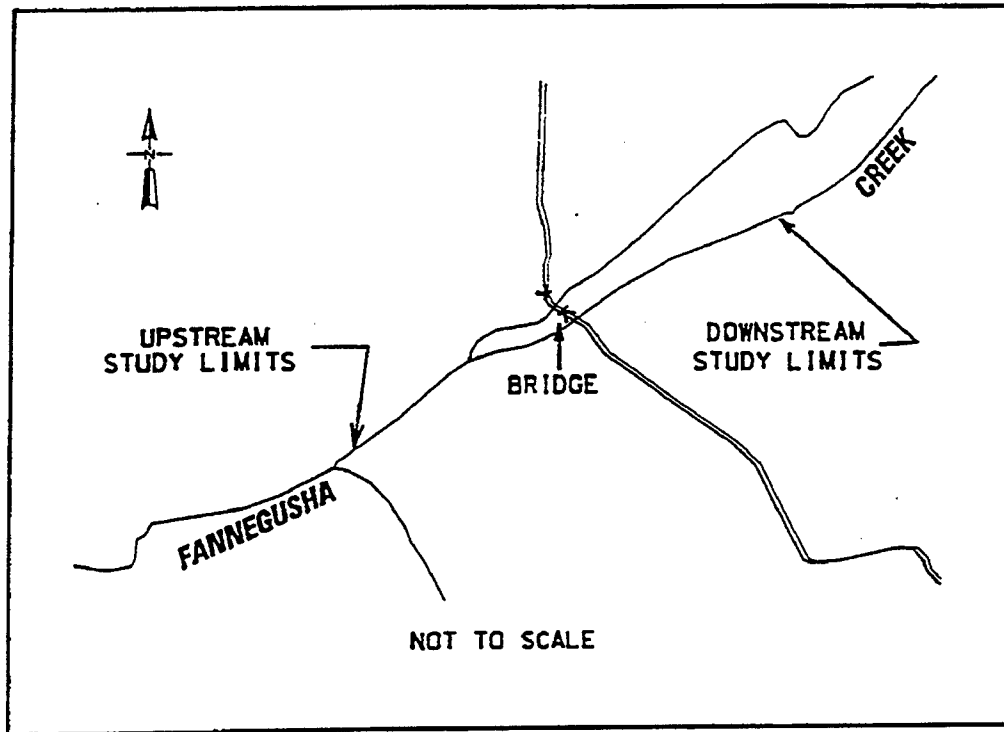
Figure 20. Fannegusha Creek, site #2

Site No. 2 is located on Fannegusha Creek, also in the Black Creek watershed, and can be found on the Coila quadrangle map in T16N, R3E, Sections 1 and 2. As shown in Figure 20, the study reach is approximately 4,000 feet in length, 2,000 feet upstream and downstream of a county road bridge. The watershed area at the site is approximately 18 square miles. HEC-1 hydrology and HEC-2 hydraulics were developed by Northwest Hydraulics Inc. (1989). This reach was chosen as representing a very unstable sandbed channel. See Table 7 for summary results and Figure 21 for thalweg profiles.

A low-drop structure was constructed in 1993 approximately 1500 feet downstream of the bridge. The stream bed appears to be aggrading for a distance of approximately 1500 to 2000 feet upstream of the structure. The bridge was replaced in 1994 due to earlier channel widening. Observations indicate that the channel will continue to widen as over-steepened banks continue to fail, due to previous bed

degradation.

Bed degradation upstream of the bridge will continue as a headcut progresses upstream. At present, the headcut is located approximately 1200 feet upstream of the bridge. Another grade control structure has constructed upstream of the study reach; however, the primary sediment supply to the reach may be entering the channel in a large left bank tributary that is near the upstream extent of the study reach. An investigation of this tributary is recommended for the purpose of developing stabilization plans.

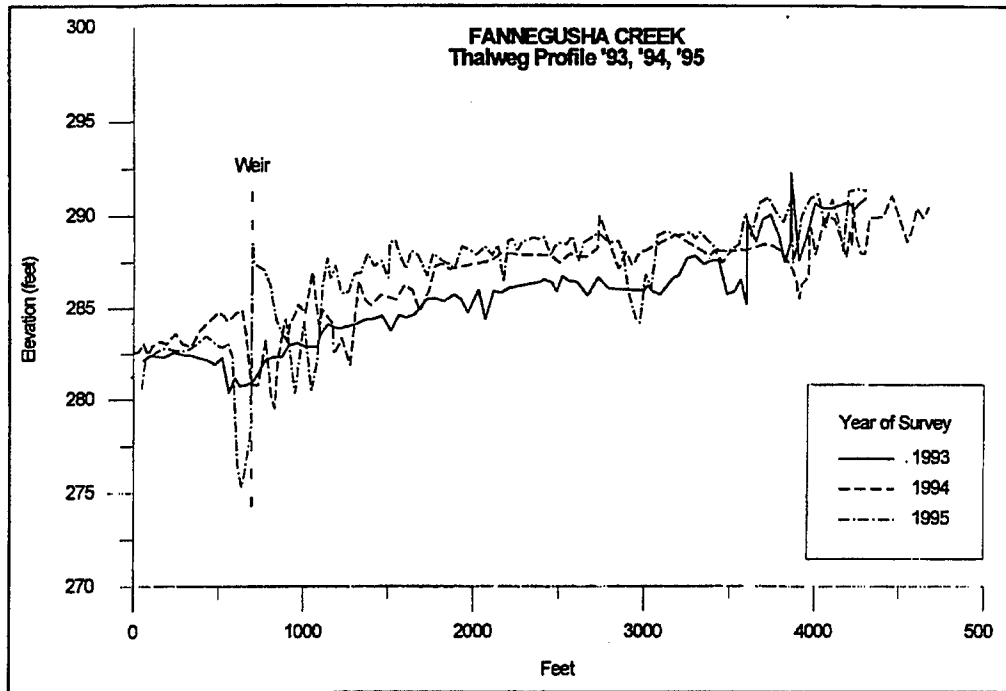
Figure 21. Thalweg profiles for Fannegusha Creek, site #2

BURBANK results (Table 8) indicated the banks are generally stable. The reach averaged SAM results portray a generally stable hydraulic condition; however, the channel response to the recently constructed grade control structure is very dynamic and continue upstream. Although the upstream portion of the study reach is a CEM 2, the overall reach has been classified CEM 4.

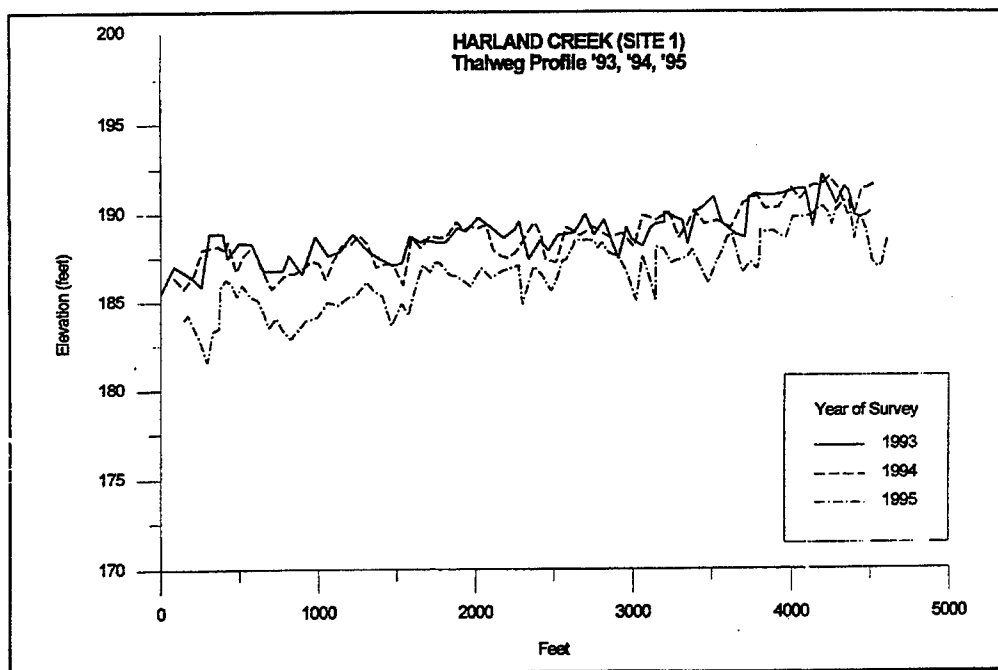
Figure 23. Thalweg profiles for Harland Creek, site #1

The thalweg profile (Figure 23) for the reach indicates a consistent degradation along the reach. Field evidence indicates that the reach has degraded, and significant bank erosion was noted. The longitudinal riprap placed in the lower 2000 feet of the reach experience minor launching, and no bank instability was noted along the riprap. The upstream, unprotected, portion of the reach had severe and consistent bank erosion, demonstrating the effectiveness of the downstream riprap. Additional bank stabilization for Harland Creek should be considered. A short gap in protection on the left bank downstream of the left bank tributary should be considered for construction.

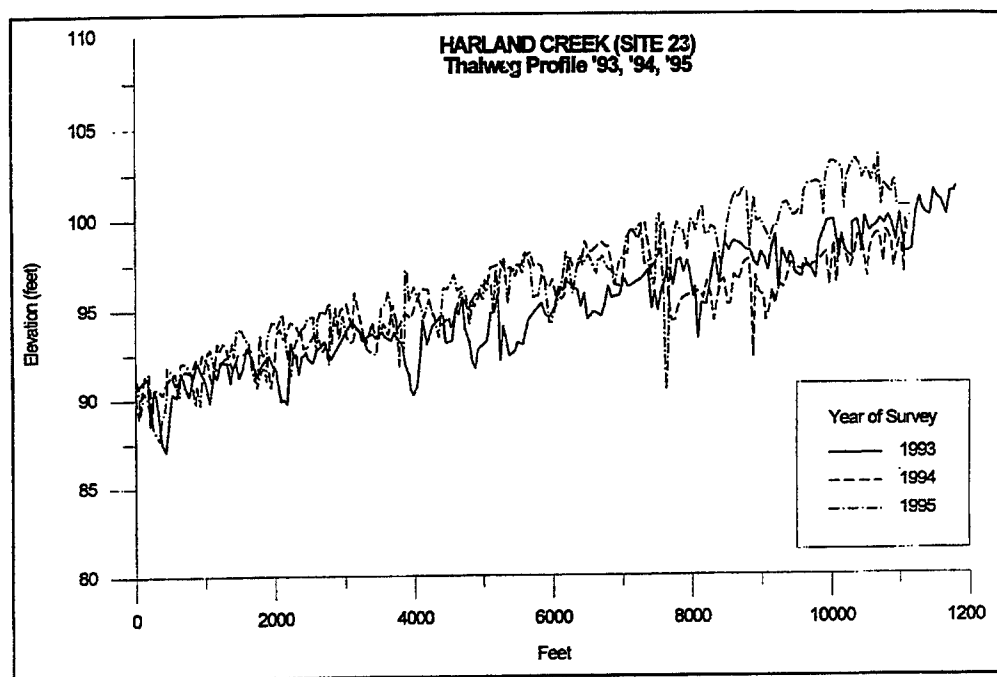
Figure 25. Thalweg profiles for Harland Creek, site #23

As shown in the thalweg profile, Figure 25, the primary difference between the

Large gravel bars were observed in the field inspection of October, 1994. Some of these bars were in atypical positions for a meandering stream, indicating that the deposits occurred during the recession of a major flood event. It is expected that lower flows will continue to re-work these deposits. Two additional factors that may contribute to the aggradation is the degradation of the upstream site, and the increased roughness caused by the bendway weirs and the willow posts.

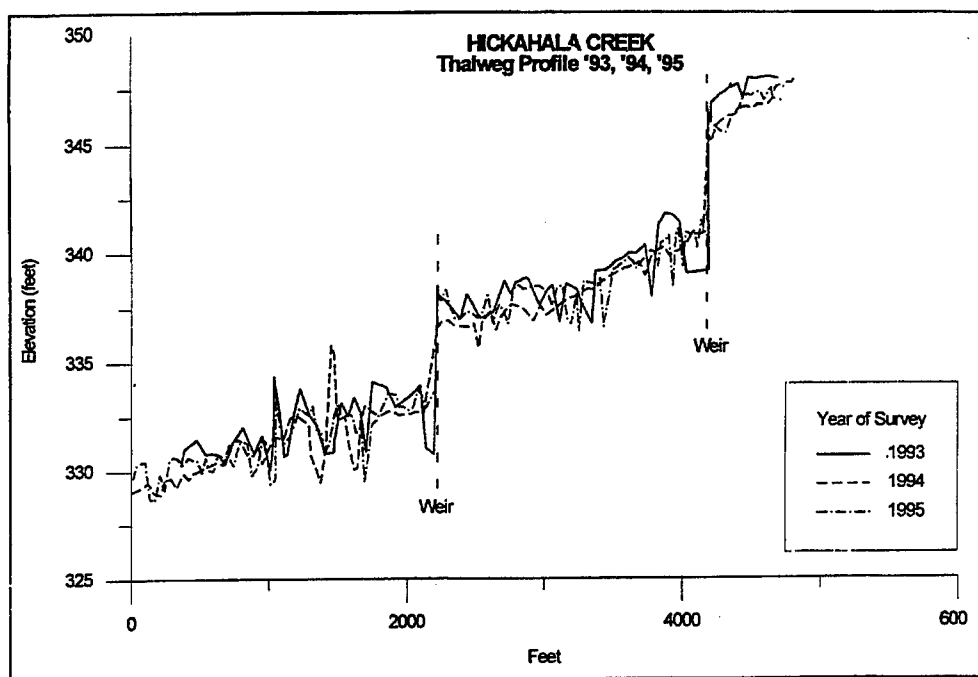
Figure 27. Thalweg profiles for Hickahala Creek, site #11

The downstream portion, Segment 1, is not influenced by a downstream grade control, although County bridge construction at the time of the last inspection may provide some control. The bed of Segment 1 is the erosion resistant clay commonly found at knickzones, and has been classified as CEM 2. The thalweg profile indicates that the bed is eroding very slowly (Figure 27). Some filling was observed in Segment 2 as a result of the downstream grade control structure.

SAM results indicate that hydraulic slope is continuing to increase and to narrow, and BURBANK results indicate that the banks are stable for the conditions tested for Segments 1 and 2 (Table 11). Segment 2 should continue to respond to the structure with filling in the lower and middle portion of the segment, and the upper portion may degrade at the upstream structure lower apron. Segment 1 will continue to slowly erode until the clay material is breached, at which time headcutting will resume. At the time of the last inspection, an active headcut was observed in the upper portion of Segment 1.

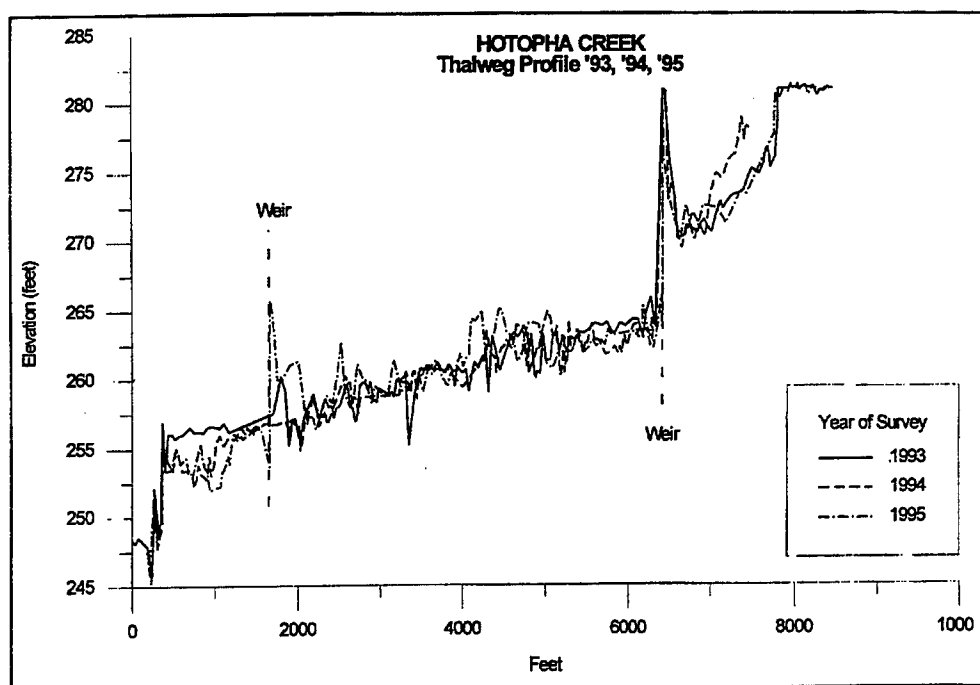
Figure 29. Thalweg profiles for Hotopha Creek, Site #13

The thalweg profile, Figure 29, indicates that degradation is occurring in Segment 1, and is moving upstream to the downstream high drop. This incision is in response to sediment storage in the upstream structures. The surveyed profile indicates that some filling has occurred in Segment 2, and that very little filling occurred in segment 1. The three high drop structures and the upstream drop box culvert have provided massive sediment storage and pooling of water, and the response to these structures will occur slowly. The pools upstream of the high drop may persist for several years, and biological sampling could document the changes in habitat as the pools evolve.

All three segment have been classified as unstable, and each segment is ponder by the downstream structure. Segment 1 is degrading in response to the reduction in upstream sediment supply, and segments 2 and 3 are filling slowly. No CEM classification was made due to ponding, which was not a condition envisioned in the original model. The SAM calculation of the sediment transport capacity for Segment 1 is 3.5 times the capacity for Segment 2, and Segment 1 is 1.6 times the Segment 2 capacity. Therefore, Segment 1 will degrade and Segment 2 will continue to aggrade if sediment supply is available. BURBANK results indicate bank instability can be expected, especially if the zero friction angle assumption occurs (Table 12).

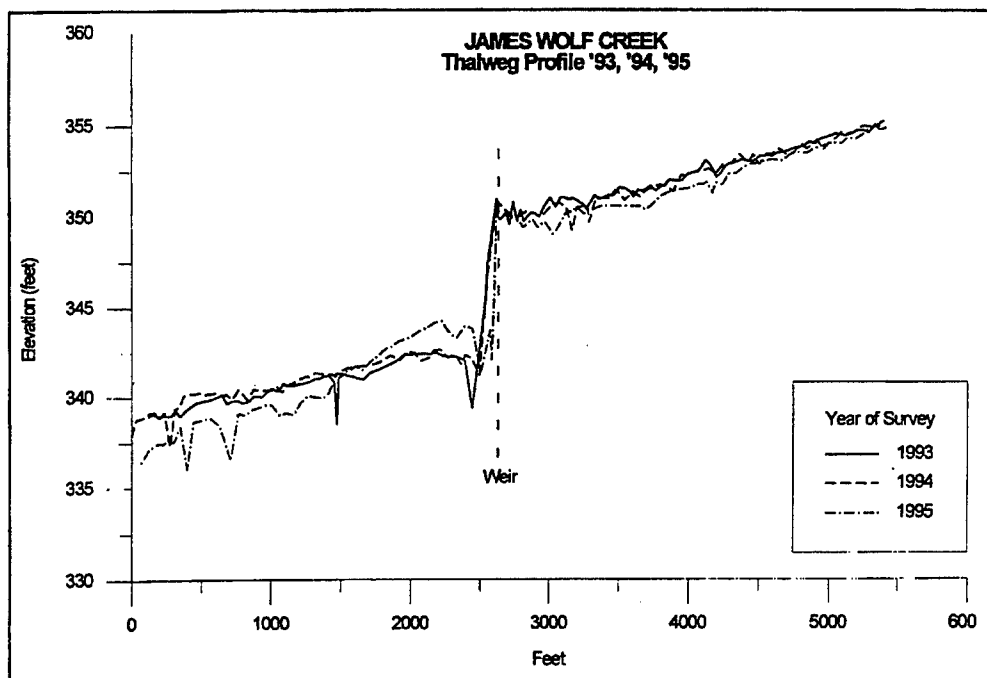
Figure 31. Thalweg profiles for James Wolf Creek, site #19

The thalweg profile indicates that both segments degraded on the order of 1 to 2

feet (Figure 31). Sediment transport capacity in the range of 3000 mg/l and the channel slope, 0.0017, are approximately the same for both segments. BURBANK results based on surveys prior to the longitudinal riprap emplacement indicate that Segment 1 banks are 100% at risk, and that Segment 2, upstream of the structure, are 50% to 60% at risk. The Segment 1 bank stabilization should improve stability. SAM results indicate that the channel is relatively steep and wide at the 2-year discharge (Table 13).

Rebuilding the drop structure and downstream longitudinal riprap improves the stability of this system. Kudzu will continue to dominant the vegetation, restricting development of more desirable vegetation that could improve bank stability and increase roughness. However, channel response is slow and the rate of change is dependent on upstream sediment supply.

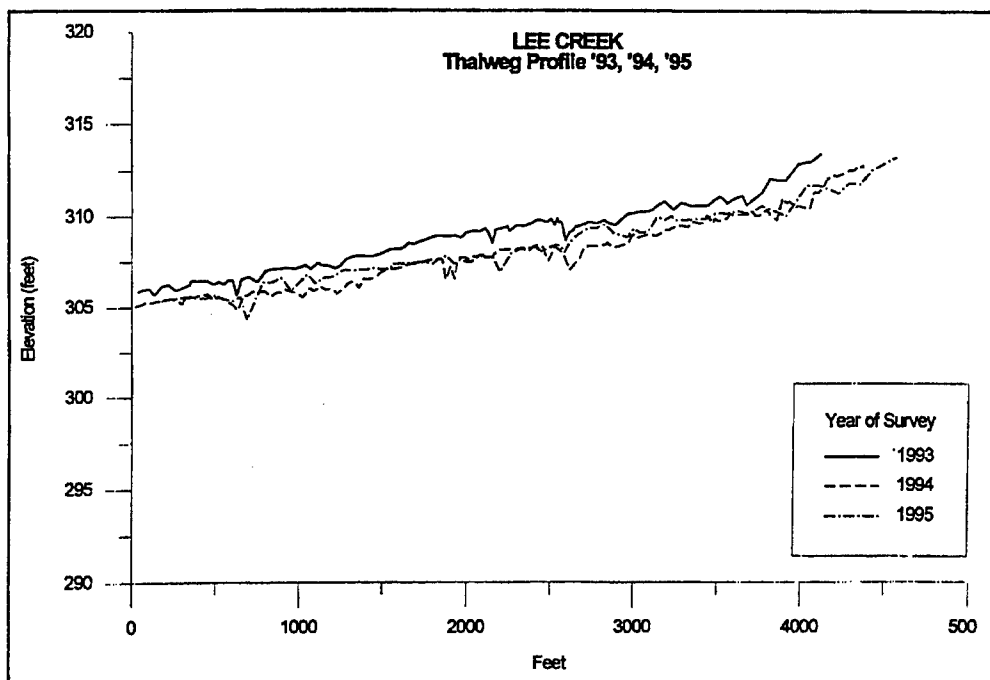
Figure 33. Thalweg profiles for Lee Creek, site #10

During October, 1994 discussions with Mr. John Kearl, the property owner at the site, he requested a drop pipe be considered for the left bank in the filed upstream of the site. He also alluded to the loss in conveyance at the site. The upstream channel banks are in a cotton field and are covered with kudzu. Debris and willow trees in the channel have formed divided flow reaches in the upstream portion of the reach. Consideration should be given to eradicating the kudzu, channelization, and re-vegetation. The downstream channel has little kudzu due to cattle feeding, birch trees along both banks, and have better conveyance and stability.

BURBANK results indicate confirm that the banks are stable. SAM results indicate that the slope has changed little since 1993, however, average width is decreasing due to upstream loss of conveyance (Table 14).

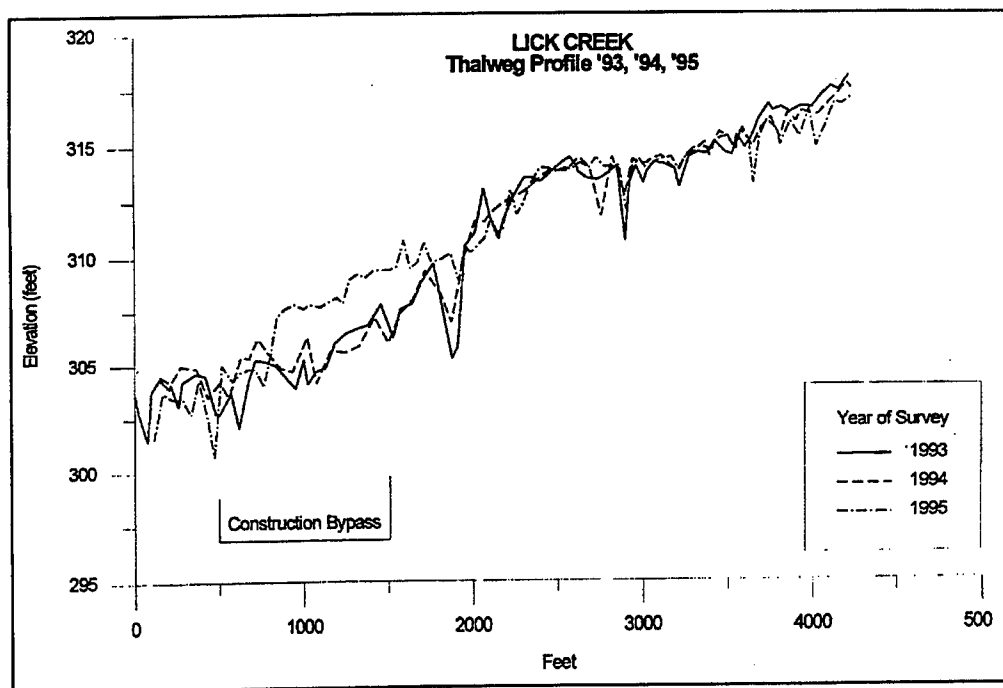
Figure 35. Thalweg profiles for Lick Creek, site #8

A high-drop structure was under construction at the time of the November, 1994 field inspection, and is located at approximate station 18+00 of the accompanying thalweg profile, Figure 35. The construction was not complete at the time of the January, 1995 survey, and the survey was made through the construction bypass as indicated in the figure. As shown on the thalweg profile, the riprap placed at the bridge (Station 20+00) as a temporary measure has helped to slow the incision that is continuing upstream and downstream of the bridge. Degradation is continuing downstream of the structure and can be expected to continue after the closure of the structure. The backwater of the structure should assist in halting the upstream incision if the knick zones have not progress too far upstream to be affected by the high drop. The high drop will protect the highway bridge. In general, the Lick Creek site is a CEM type 3 downstream and through the bridge, is a type 2 at the upper extent of the site. Presently, the upstream extent of the site is incising into resistant clay (Table 15).

The SAM analysis indicates that the slope width has been increasing. BURBANK analyses indicates that three feet of additional degradation will destabilize 50% of the Segment 1 surveyed banks and 12% of the Segment 2 surveyed banks with the assumption of zero friction angle. Left bank drainage upstream of the bridge is poor, with standing water in the adjacent field. Channel incision and a saturated left bank may combine to result in greater instability than in other similar streams. A drop pipe could be added to improve bank drainage. The high drop structure will improve the stability of the upstream channel reach, and it will be of interest to observe the upstream and downstream channel response following construction completion (Table 15).

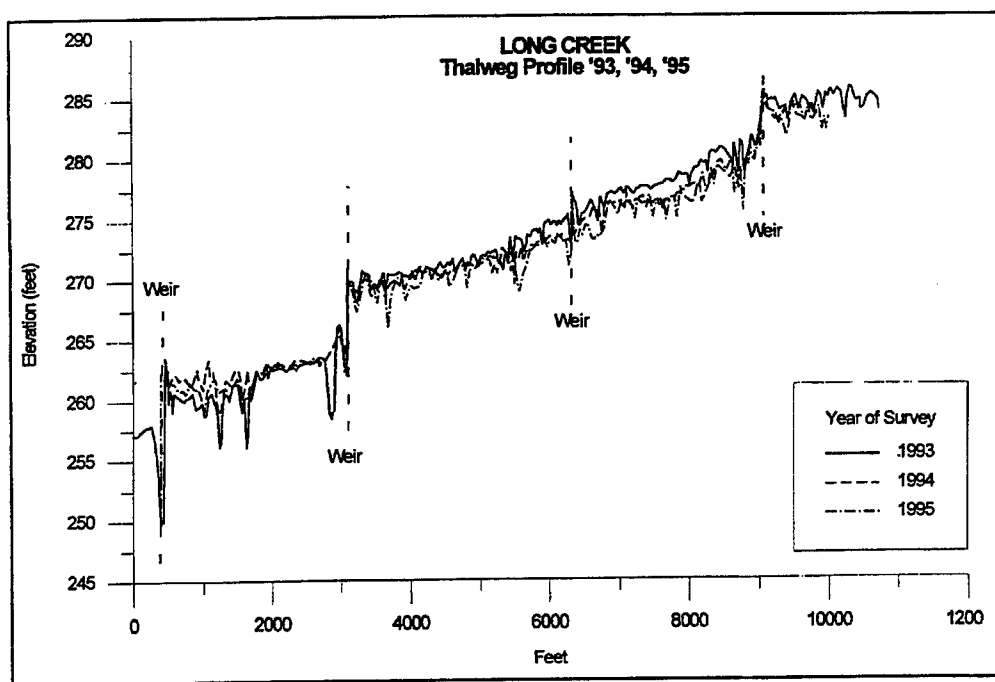
Figure 37. Thalweg profiles for Long Creek, site #20

Long Creek is divided into four segments: at station 0+00 at the fourth downstream drop structure; at approximate station 32+00 at the older low drop structure; at approximate station 68+00 at the next upstream low drop structure; and at approximate station 90+00 at the upstream weir. Figure 37 shows a thalweg profile of Long Creek. Segment 1 aggradation occurred in the period from completion of the lower drop in 1993 through the 1994 survey, and minor degradation occurred in 1994. Significant thalweg change is within 300 feet downstream of the upper weir. At this location, headcutting is moving into the weir. Numerous beaver dams that are present in segments 2, 3, and 4.

BURBANK analyses shows the significant improvement in bank stability moving upstream from Segment 1 at 33% to 0% in Segment 4. Without structural control, degradation would be continuing and the effects of 3 feet of degradation indicated in the tabulation are from 100% in Segment 1 to 6% in segment 4, which demonstrates one of the positive aspects of low drop grade control (Table 16).

Monitoring of the longterm slope adjustment of the site will furnish unique information pertaining to channel adjustment in a channel that is limited in width adjustment. From an operational viewpoint, degradation is moving up to the upstream weir and should be monitored for the safety of the structure. The upstream weir is not a low drop structure; it is an at-grade sheet pile and concrete cap with no stilling basin.

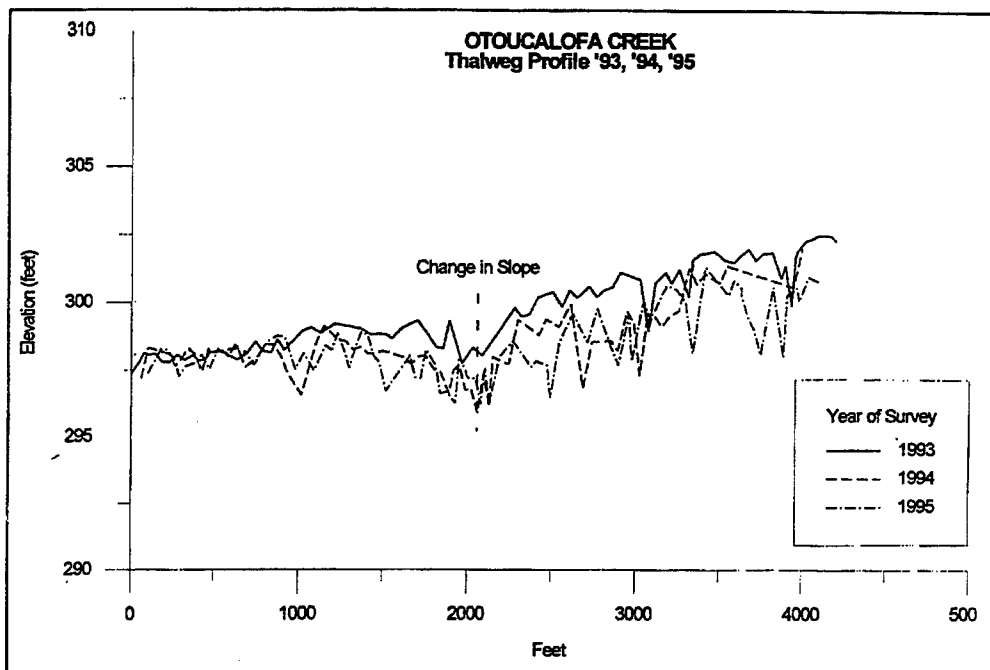
Figure 41. Thalweg profiles for Otoucalofa Creek, site #14

Presently, only riprap dikes and longitudinal dikes are constructed throughout the reach. The reach was observed to be actively incising in 1994 and this incision is occurring at an elevation below the recently placed stone. This site provided a unique opportunity to observe the riprap subjected to severe degradation, and some of the stone placed in the upstream Segment 2 has launched and was no longer visible during the November, 1995 inspection.

BURBANK results indicate that the banks are stable, and SAM results are generally consistent with the CEM 3 designation given.

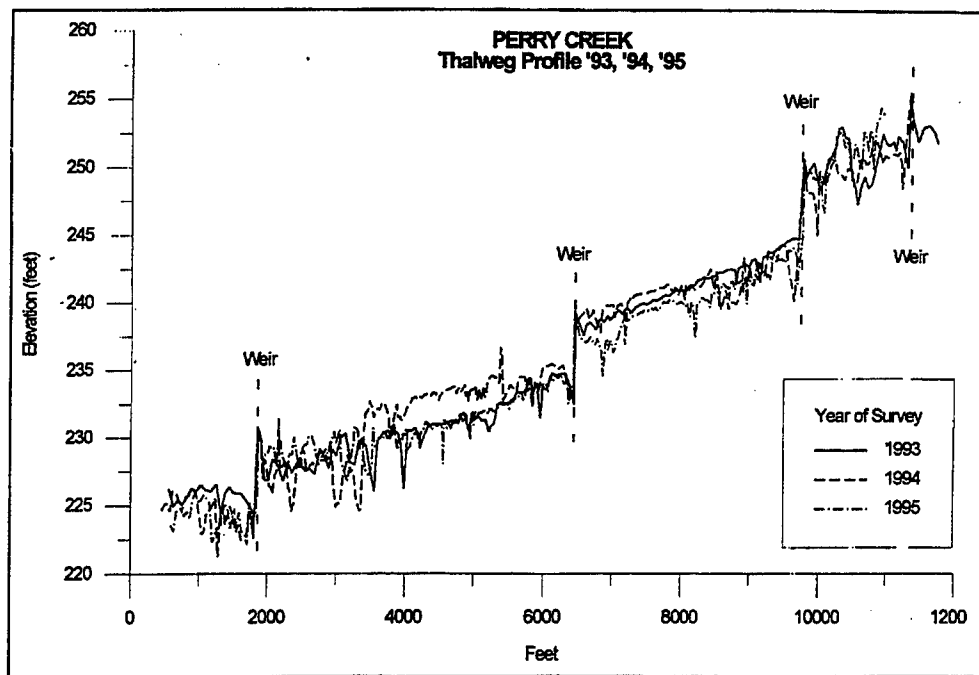
Figure 43. Thalweg profiles for Perry Creek, site #16

Downstream of the lower grade control structure, Segment 1, is ponded as a result of a downstream shale outcrop. The extent and durability of the shale is unknown, and failure of the existing headcut will result in 2 to 3 feet of degradation moving into the structure (Perry #3). Upstream of this structure, the channel is ponded. Segments 1 and 2 transport less than 1000 mg/l. Segment 3 is responding to the structure (Perry #4) and some incision is continuing upstream. A gully on the left bank approximately 500 feet downstream of Perry #5 should be considered for a drop pipe. Although the slope in Segment 4 is very steep, the bed is relatively erosion resistant ironstone and may respond slowly.

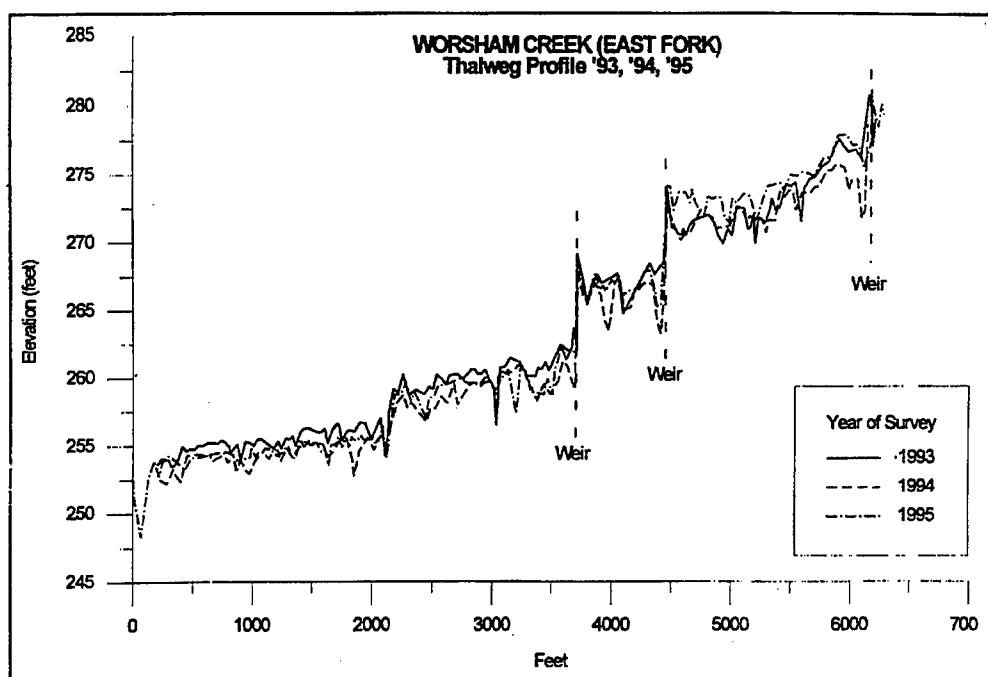
Figure 51. Thalweg Profiles for East Worsham Creek, site 18a

Upstream of No. 2 structure, in Segment 3, the 1995 survey indicates that significant aggradation has occurred. The upper portion of Segment 3 is a hard, erosion resistant clay that has changed little in the past four years. A beneficial effect of the upstream grade control structures can be realized by comparing the BURBANK analysis of the percentage of bank at risk for the zero friction angle condition in 1995. Grade control has raised the channel bed to reduce the percentage of bank unstable from 100% in Segment 1 to 5% in Segment 3. This is a significant improvement. However, the SAM results indicate that the 2-year slope in all segments remains very high at approximately 250% of the 1000 mg/l minimum slope. See Table 22 for summary results and Figure 51 for thalweg profiles of site 18a.

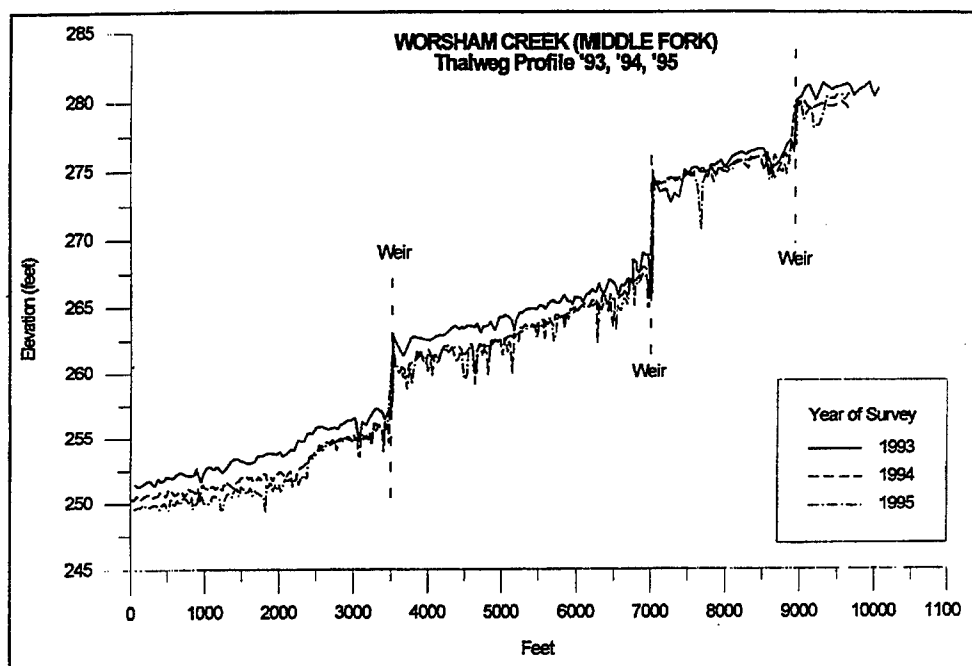
Figure 52. Thalweg profiles for Middle Worsham Creek, site 18b

The downstream extent of Middle Worsham is at the confluence with West Worsham Creek. The total reach is approximately 10,000 feet in length and is divided into four reaches by three ARS-type, low drop structures. See Table 23 for summary results and Figure 52 for thalweg profiles. The accompanying thalweg profile, Figure 52, depicts the degradation that has occurred since 1992 in the lower two segments. The primary location of degradation during the 1994-1995 period was the downstream portion of Segment 1. The table of BURBANK results clearly shows the value of the grade control structures in reducing or maintaining low bank height. Percentage of

bank height unstable for the zero friction angle decreased from 67% in the lower reach to only 3% for the upstream reach. Unfortunately, in the lower reach with no grade control, the percentage of bank unstable will increase as the channel degrades. Minor degradation is continuing at the upstream extent of Segment 2, and incision was observed in the field at Segments 1 and 2. Sediment has filled to the crest of the structure in Segment 3.

Immediately upstream of the confluence of West and Middle Worsham, Segment 1 has a shallow depth of sand, less than 2 feet, for most of segment up to the confluence with East Worsham. Upstream of this confluence, the channel is narrower and nick zones are present. Two drop pipes had been cleared for surveying in 1994 and were not constructed in 1995 in this reach. Again in Segment 2, as the upstream structure is approached nick zones are present and massive bank failures are present. Headcutting in the upstream portion of Segment 3 is moving into the older structure at a slow rate, and the upstream structure basin has significant sand deposits and willow growth. Upstream of the third structure, knickpoints are present at several locations. The right bank is eroding and consideration should be given to fencing the right bank upstream of the third structure to limit cattle access. Consideration of some form of grade control should be made at the upstream extent of Segment 4.

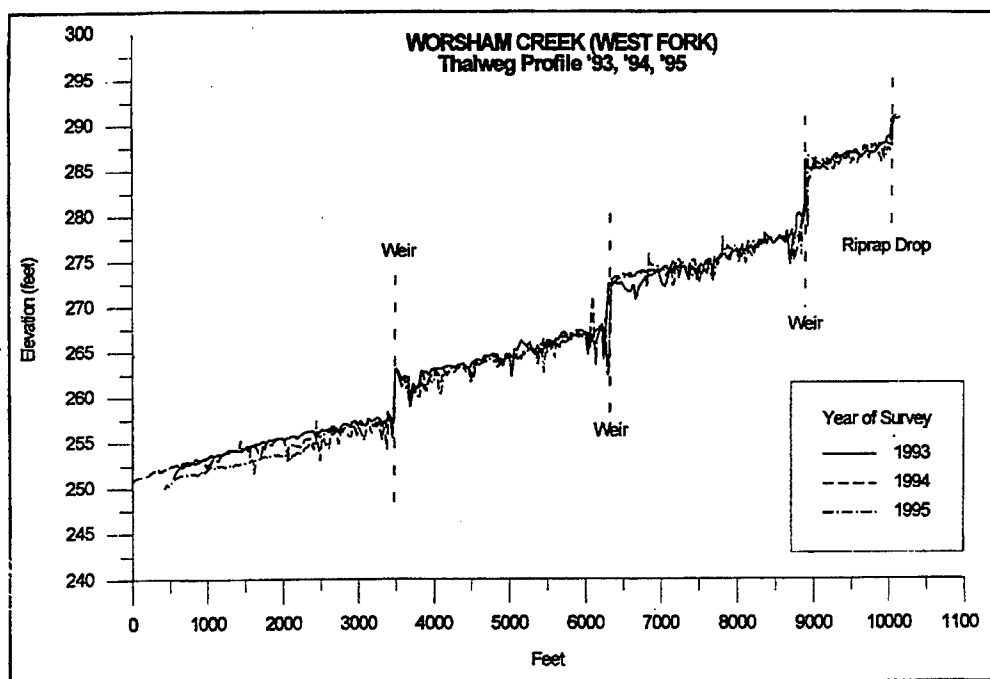
Figure 53. Thalweg profiles for West Worsham Creek, site 18c

The total reach length is approximately 10,000 feet and is divided into four segments by three ARS-type low drop structures. See Table 24 for summary results and Figure 53 for thalweg profiles. The accompanying thalweg profile, Figure 53, indicates continuing degradation in the lower segment, and clearly indicates the aggradation immediately upstream of the second structure. Note that the 1995 profile indicates filling to the weir crest of the second structure, while the older, first structure has not filled. This indicates that the improved hydraulic control of the newer design results in improved performance, and suggests that renovation to improve hydraulic control is worth consideration.

The table of BURBANK results indicates that banks are relatively stable, except in the lower segment. This was confirmed by field inspection in November, 1995. Continued degradation will exacerbate Segment 1 bank stability. Consideration should be given to construction of grade control in the segment.

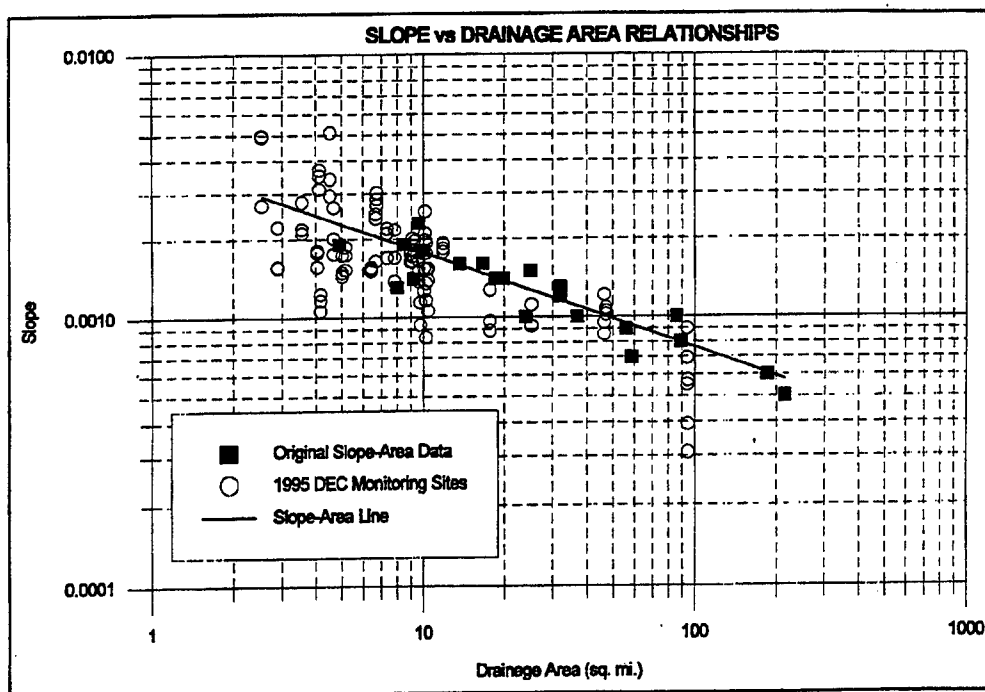
Figure 54. Slope vs drainage area relationship

of stable channel reaches. Figure 54 depicts the original data, the regression of the original data, and data from the 1995 DEC monitoring reaches. Stability was generally defined in terms of the Channel Evolution Model (CEM) (Schumm, et al., 1984). Regression of the original data used in GDM No. 54 results in the following relationship:

One factor to consider is that drainage areas for the DEC monitoring reaches are generally smaller than the original-data drainage areas. As shown in Figure 54, only one reach less than 8 square miles was included, whereas, the DEC monitoring reaches are primarily in the range of 2 to 10 square miles. Figure 55 is a comparison of the DEC monitoring reach energy slope data shown as CEM types, and the GDM No. 54 slope-area curve. For the portion of the slope-area curve greater than 10 square miles, most of the reaches are CEM 4 or CEM 5, indicating a reasonable degree of stability. For drainage areas less than 10 square miles, the slope-area curve is defined by CEM 2 or CEM 3, generally unstable reaches. The CEM 4 less than 10 square miles in drainage area are below the relationship.

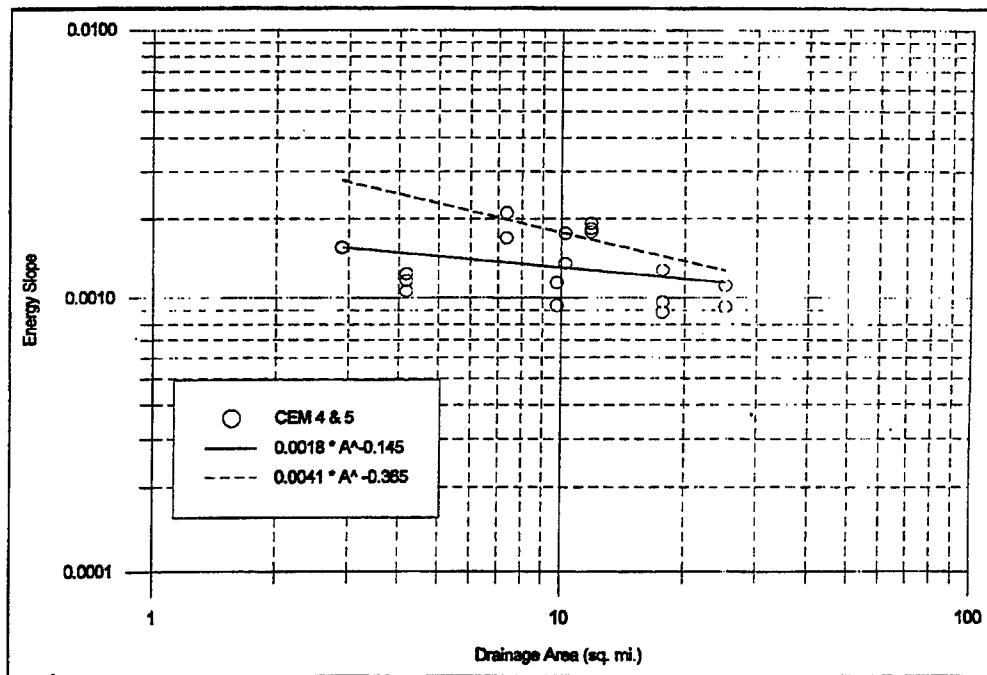
Figure 56. 1995 CEM data with two regressions

Figure 56 is similar to Figure 54, with the following exceptions: a.) 1995 DEC monitoring reach data for only CEM 4 and CEM 5 reaches are plotted; and b.) these data exclude reaches that are ponded because ponding was not included in the original conception of the CEM. A new regression was made of the plotted data and the following relationship was plotted using a solid line (Figure 56):

using the same parameters as previously noted. The GED No. 54 relationship is shown above as the dash line. One of the primary reasons for lowering the relationship is that

the sediment supply to the reaches has been reduced by the numerous drop pipes, land use improvements, and bank stabilization measures that have been emplaced by the DEC programs. Stability, as defined by the CEM criteria, includes a balance between sediment supply and sediment transport capacity. As the sediment supply has been reduced, the stable slope must also be reduced. Therefore, although the slope-area curve is a useful benchmark for comparison of reaches, the curve will require updating as success occurs in reducing sediment supply. The new relationship has a statistically poor fit; however, it demonstrates that the slope-area relationship must be re-evaluated. Consideration should be given to using design procedures that explicitly include sediment supply and transport capacity.

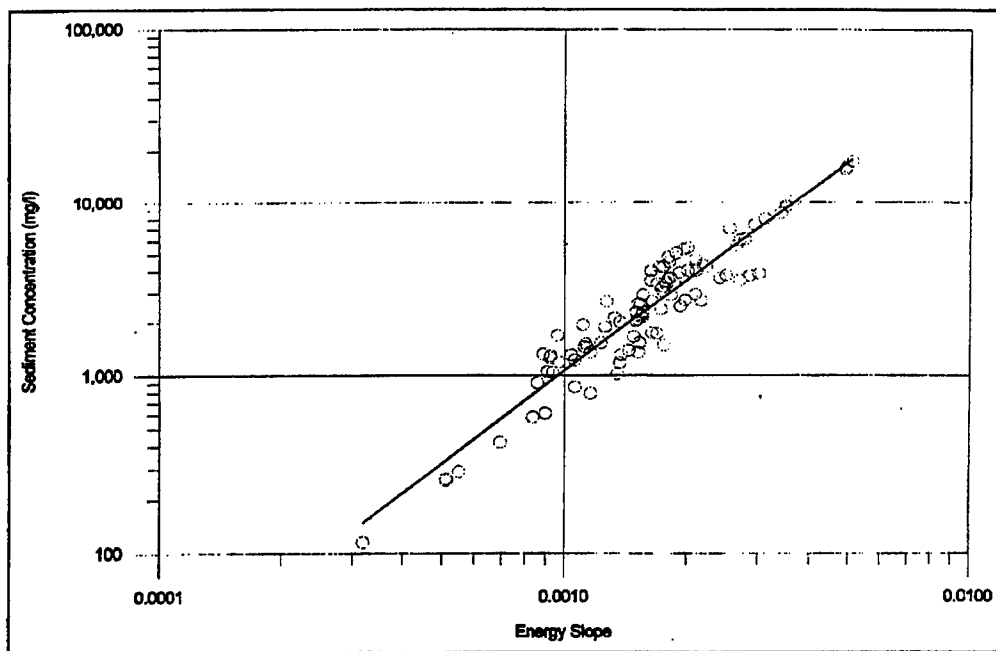
Figure 57. Relationship between energy slope and computed sediment concentration
For DEC monitoring reaches

Unfortunately the slope-area regional stability curve, although useful, does not explicitly include sediment yield or sediment transport capacity. The relationships only implicitly include the sediment yield of the stable channels used in the data base. Figure 57 depicts the relationship between the energy slope and the computed sediment concentration in the DEC monitoring reaches. A regression expression for the data is:

with the units of concentration as mg/l, and S is the energy slope. The coefficient of determination (R^2) is 0.89. As shown in Figure 4.4, the sediment concentration for $S = 0.0009$ is approximately 1000 mg/l, for $S = 0.004$ the concentration is approximately 10,000 mg/l. Figure 4.5 shows the slope-area curve from GDM No. 54, and has values of sediment concentration taken from Figure 4.4 for selected drainage areas. Therefore, using the slope-area curve for stable channel design would require the designer to accept 712 mg/l at 90 square miles, 2849 mg/l at 10 square miles, and extrapolating the relationship, 7170 mg/l at 2 square miles.

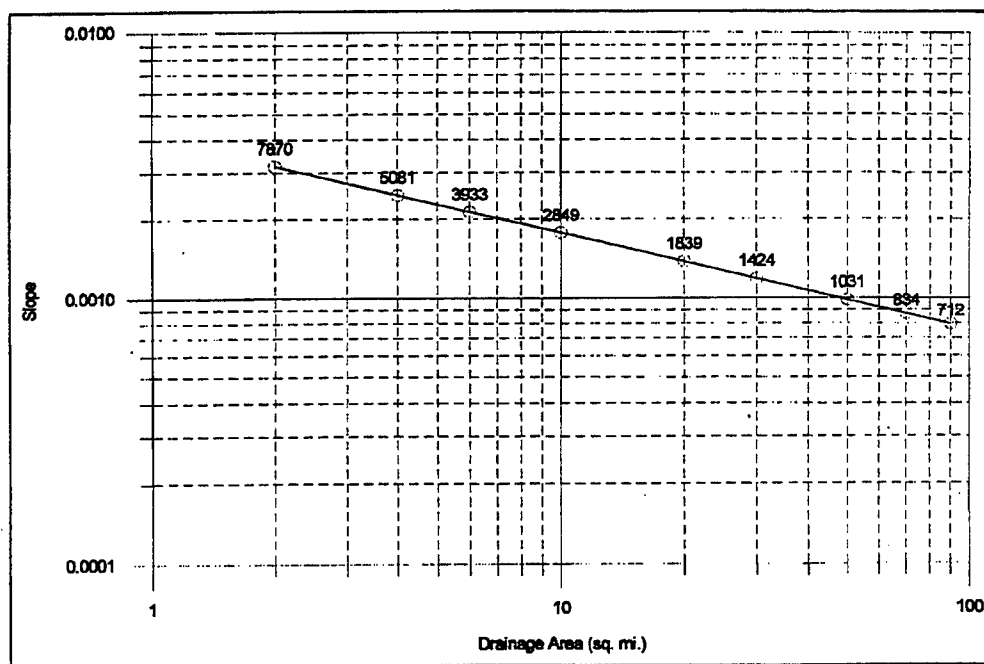
Figure 58. Sediment concentration for the 2-year discharge along the GDM No. 54
slope-area curve

The consequence of designing grade control using the GDM No. 54 slope-area curve, when considered in a sediment transport frame of reference, can be examined in a general sense using data from the DEC monitoring reaches. The average sediment transport capacity expressed as a concentration for all of the DEC monitoring reaches at the 2-year discharge is 3428 mg/l. The average drainage area for the DEC monitoring reach segments with grade control is 7.4 square miles, and from Figure 4.5 the average sediment concentration is 3446 mg/l using the GDM No. 54 slope-area curve. Therefore, reaches that include grade control structures designed using the GDM No. 54 slope-area curve may reduce sediment concentration in those reaches, however, the reaches would continue to contribute sediment at the same or greater concentration as compared to the present overall average concentration. A new procedure should be considered to enable design for reduction of sediment yield.
